Case History

Balancing an over fire air fan (OFA)

by John Kingham

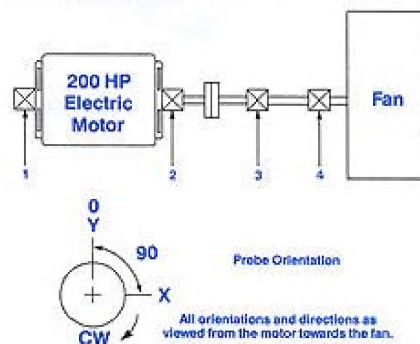
particular. This unit was a 200 HP fan of overhung, squirrel cage design utilizing rolling element bearings for rotor support (Figure 1).

Figure 1
Machinery arrangement diagram

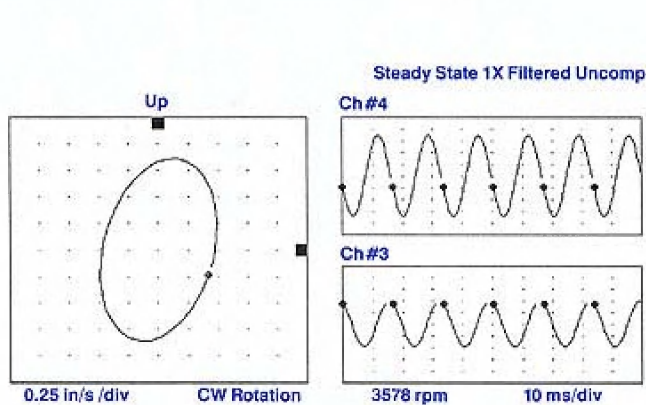
balancing attempt as well. The bearing closest to the fan, bearing #4, had overall amplitudes of 0.68 in/sec (17.27 mm/sec) peak horizontally, and 1.02 in/sec (25.9 mm/sec) peak vertically. The 1X amplitudes were 0.52 in/s (13.2 mm/sec) peak at 331° and .89 in/sec (22.6 mm/sec) peak at 254°, respectively (Figure 2).

Figure 2
Initial steady state data for Bearing #4

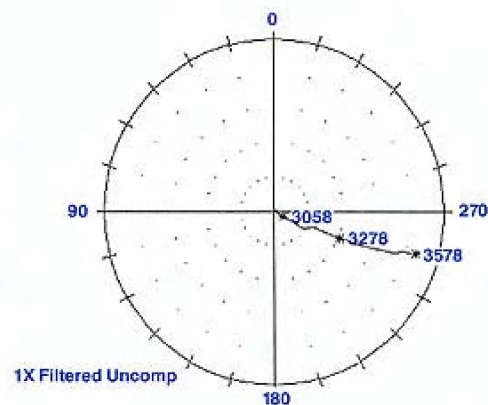
An initial attempt at balancing was made by placing 11 grams of weight at 180° against rotation (AROT) on the inboard wall of the impeller. This weight and location was determined from a review of the Polar plots obtained during a shutdown (Figure 3). These Polar plots also showed the rotor was operating below its first balance resonance. Upon startup, 1X levels were 0.73 in/sec (18.54 mm/sec) peak at 129° and 1.16 in/sec (29.46 mm/sec) peak at 52°. It appeared that we had applied an excessive correction and "pushed" the response vector through zero. Independent calculations, using both the vertical and horizontal response to the calibration weight, indicated that approximately 4.7 grams were needed at 192° (Figure 4).

Figure 3
Polar plot of Bearing #4 vertical shutdown

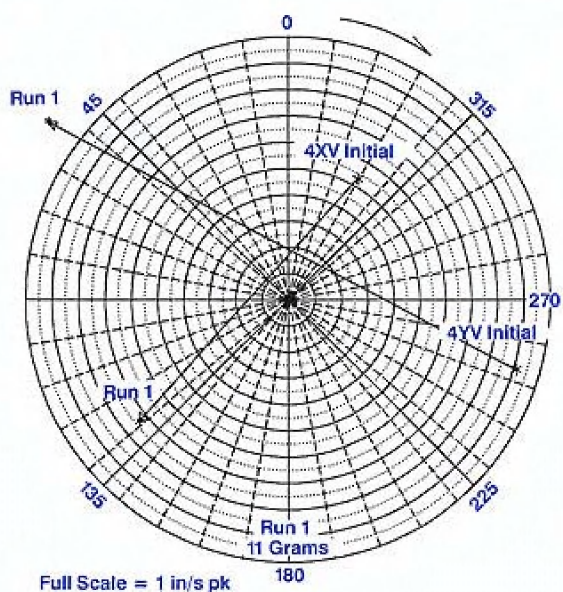
Figure 4
Graphical representation of balance data for Run 1

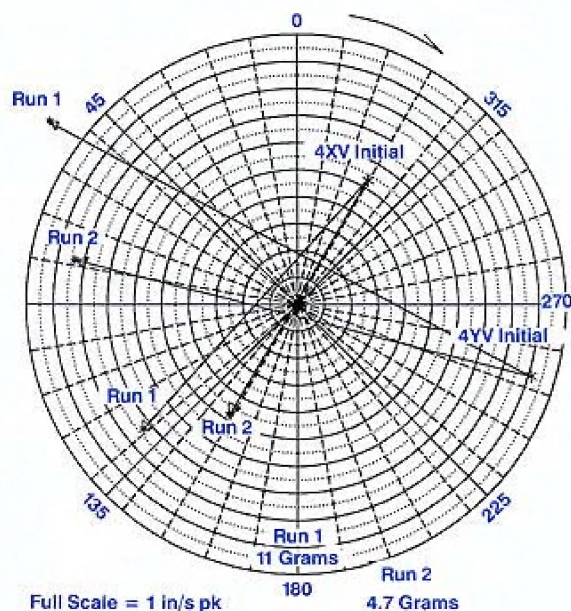
Figure 5
Graphical data after Run 2

levels of 0.48 in/sec (12.19 mm/sec) peak at 149° and 0.84 in/sec (21.34 mm/sec) peak at 79°. It was clearly evident that the fan, for some unknown reason, was not responding in a linear fashion (Figure 5).

The fan would start up with reasonable vibration levels, but shortly after reaching running speed, vibration levels and phase radically changed, accompanied by an audible difference in vibration. No further attempts to balance the fan were made. At this time, a rub was suspected due to the change in amplitudes and the audible vibration.

What at first appeared to be nonlinearities due to massive unbalance appeared now to be due to a rub situation. The fan was inspected for rubs, but none could be found. Another problem

that could have caused these nonlinearities was a looseness in the bearing support system. The #4 bearing cap was removed, and it was determined that about 3 to 5 mils of looseness existed.

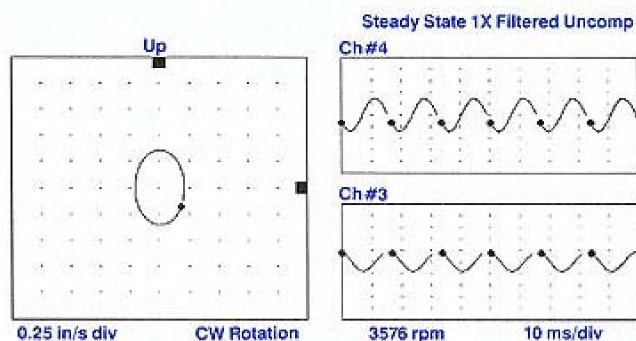
Figure 6
Steady state with 3 mil shim, before final balance

A 3-mil feeler was then placed into the top of the bearing cap, and the fan ran with a **consistent** 1X reading of approximately .21 and .35 in/sec (5.3 and 8.9 mm/sec) peak (Figure 6). It looked like the problem was corrected.

Although the fan could have been rebalanced at this time, operators decided to wait until a good bearing/pillow block could be installed. The fan bearing and pillow block were replaced, and the fan was then successfully trim balanced by the manufacturer's representative.
